Failure and Acoustic-Emission Response of Plasma-Sprayed ZrO_2 -8 wt% Y_2O_3 Coatings

N. R. SHANKAR, C. C. BERNDT, AND H. HERMAN

Dept. of Materials Science and Engineering, State University of New York
Stony Brook, NY 11794

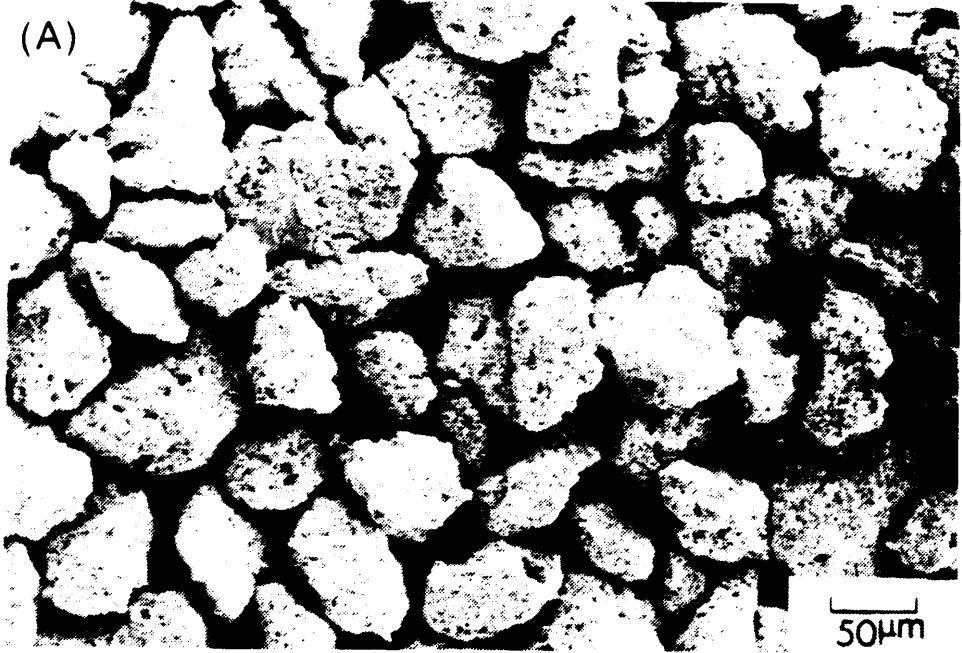
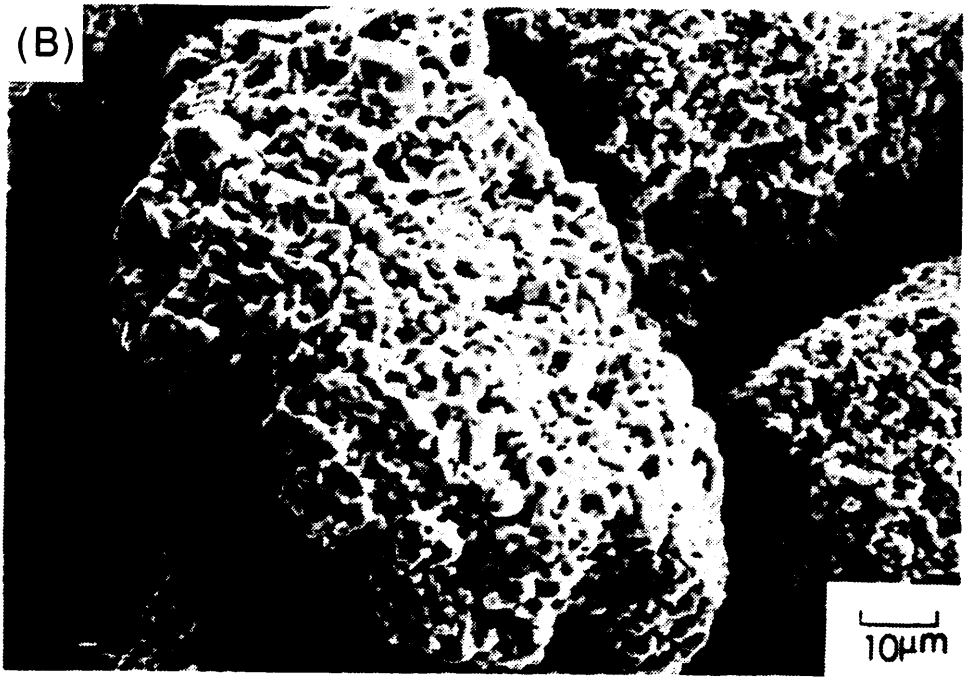
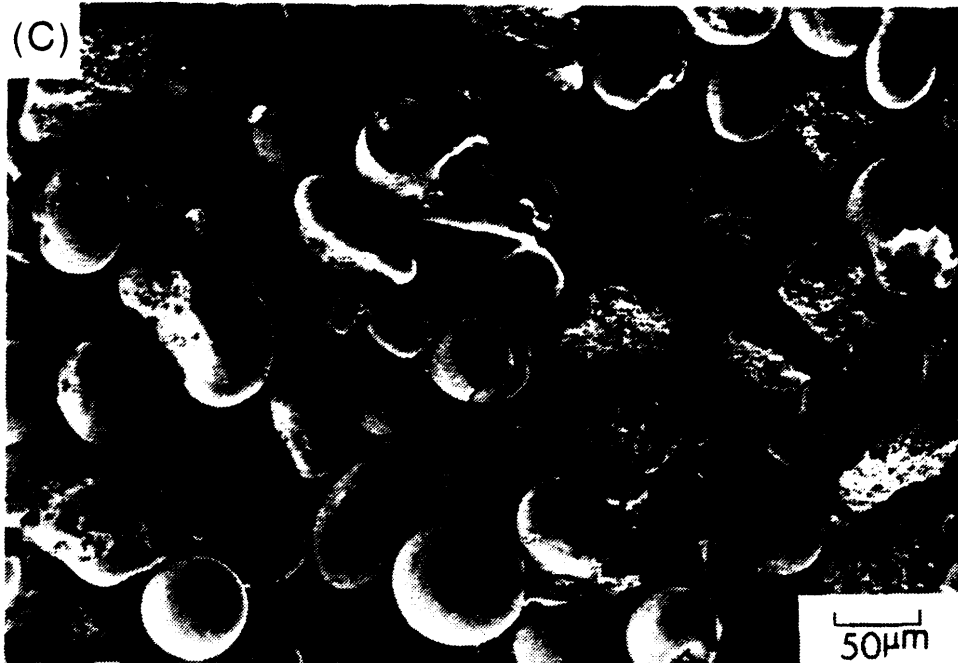
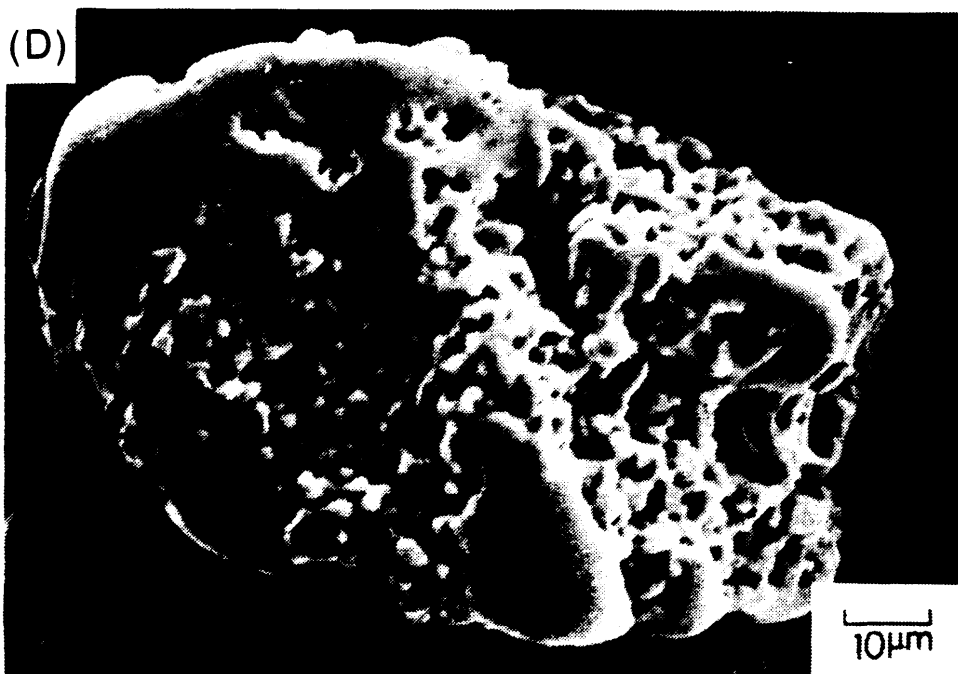
Fig. 2. Morphology of the YSZ powder: (A) as-received prereacted powder exhibiting irregular shape; (B) a single particle showing very fine surface features of 1 μ m in size; (C) H_2O -quenched YSZ powder showing considerable unmelting particles; and (D) a particle showing a partially melted surface and microcracks.

The YSZ particles, both as-received and H_2O -quenched, are shown in Fig. 2. The particle-size distribution determined by sieve analysis is shown in Fig. 3. The porous structure of the powder is due to the production method in which micrometer-size ZrO_2 and Y_2O_3 are mixed together and reacted at a high temperature. Therefore, the effective surface area of the particle is greatly increased and this would increase the heat transfer to the particles during the plasma-spraying process.

Water-quenching of the plasma-melted YSZ yields a large number of unmelted particles (Fig. 2(C)). Figure 2(D) shows a partially melted particle in which the surface was more molten than the core. The particles also exhibit many microcracks, which are expected to play an important role in any failure process. Water-quenching only influenced the particle-size distribution by slightly decreasing the range of particle diameters from $\approx 50 \mu\text{m}$ to $40 \mu\text{m}$ (Fig. 3).

The YSZ powder did not exhibit any significant **particle-distribution** change after quenching in H_2O and, therefore, the micrographs (Figs. 2(C) and 2(D)) are a good representation of the particle morphology immediately prior to **splat** deformation. Areas are exhibited which show partial melting of particles, internal porosity, and microcracks on the surface. Microcracks and porosity arise due to the **H_2O -quenching** operation but are also present in plasma-sprayed coatings (Fig. 4). The main feature is that many particles are not completely melted by the plasma effluent, and this is an excellent surface to permit **the** mechanical anchoring of other overlaying, semimolten particles.

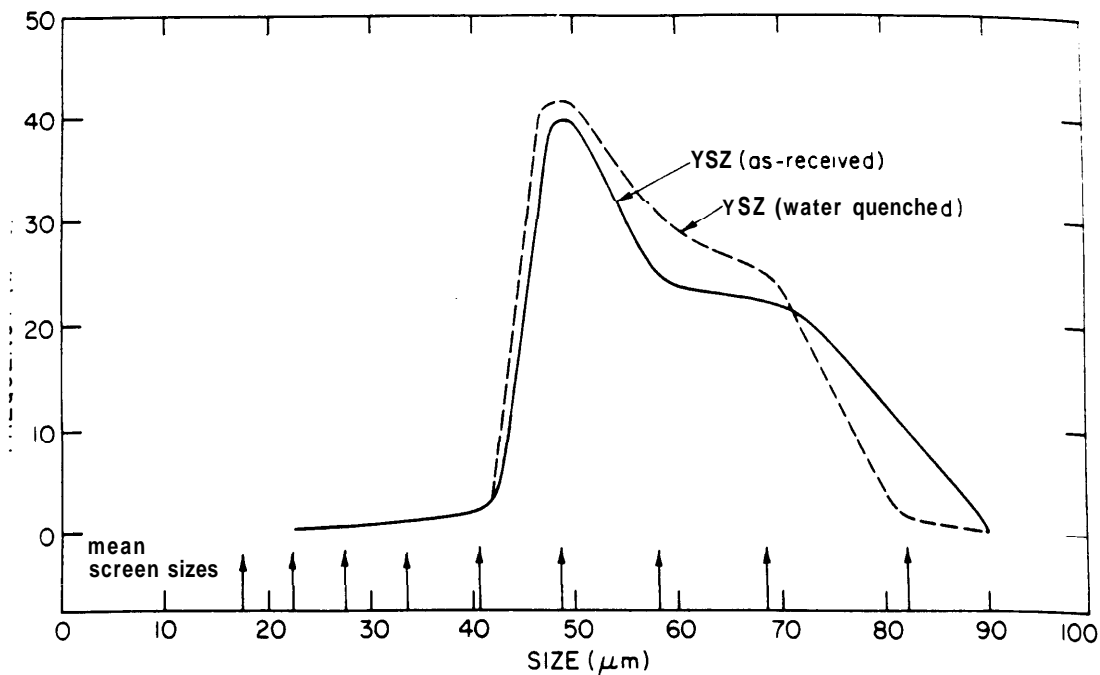
Fig. 3. Particle-size distribution of the as-received and H₂O-quenched YSZ powders.

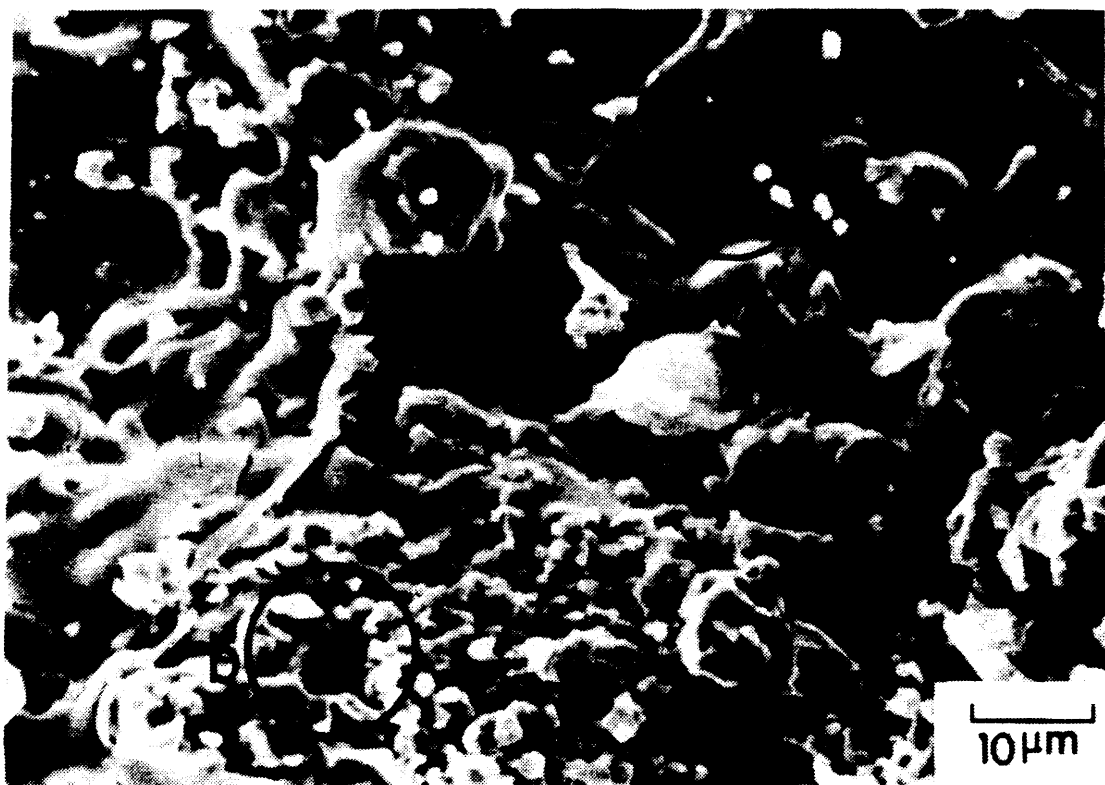
Fig. 4. Surface of plasma-sprayed YSZ coating showing regions of fine cracks (region "a") and unmelted particles (region "b").

Examination of the coating surface can give insight into the structure of the bulk of the coating. As shown in Fig. 4, the YSZ coating has many fine cracks (region "a"), as well as unmelted particles of irregular shape (region "b"). A most significant feature is, therefore, that unmelted (or partially melted) YSZ particles confirm a relatively rough surface to the coatings, compared with the fully molten case, and this is an excellent "key" to overlaying molten

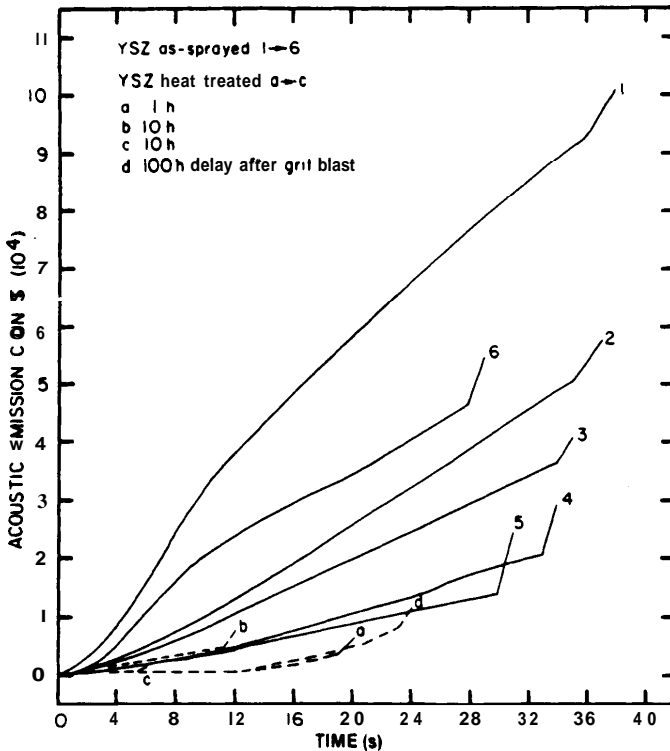
Fig. 6. Cumulative AE counts vs time of tensile-adhesion test for the as-sprayed **YSZ** coatings and coatings treated according to conditions as indicated.

The cumulative counts were obtained by integrating the count-rate data shown in Fig. 6. The relationship of the integrated AE counts with bond strength is shown in Fig. 7. These results are summarized in Table III. A statistical analysis of the count-rate data will be given in the Discussion.

Figure 6 shows results for YSZ coatings which have been as-sprayed and in some cases treated according to the conditions indicated as in the figure. The high slopes immediately prior to failure are due to the high counts generated at fracture. The specimens are numbered according to their bond strengths, with 1 having the highest bond strength and 6 the lowest bond strength among the as-sprayed coatings. Similarly, "a" has the highest bond strength and "c" the lowest bond strength among the heat-treated coatings. There was a 100-h delay between spraying and grit blasting for specimen "d." Both heat treatment and delay after grit blasting decrease bond strength and the corresponding cumulative AE counts. Decreases in AE counts and in bond strength are dependent on the length of heat treatment, with 10-h treatments being more detrimental than the 1-h treatment. Specimen 6 seems to be an exception in that it generated high AE counts but had a low bond-strength value. It should be pointed out that this is due, in part, to a rapid increase in acoustic activity during the first 9 s of the test, which is shown graphically as a high initial slope. The same phenomenon can be observed for specimen 1 in which there is a distinct knee in the AE count vs time curve after 10 s. These two specimens were unique in exhibiting this behavior, as were their rms volt-

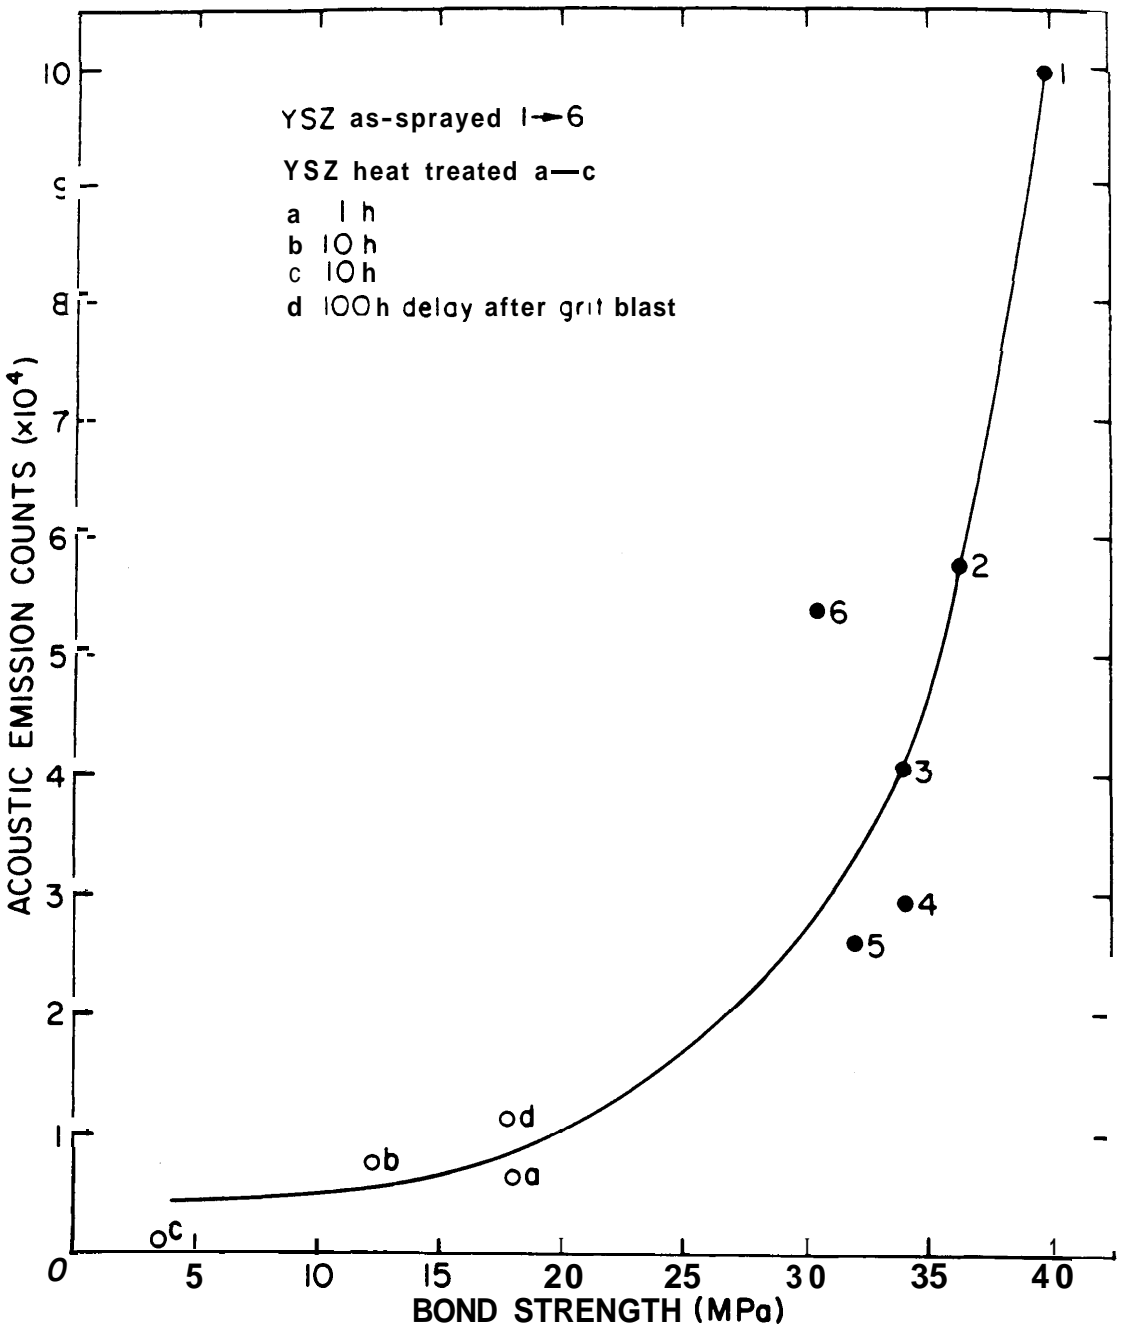
Fig. 7. Cumulative AE counts vs bond strength of the as-sprayed and treated YSZ plasma-sprayed coatings.

The total AE counts are plotted against the bond strength in Fig. 7. The general trend observed is that a high bond strength gives rise to a high acoustic-emission count, the relationship following a power law. The as-sprayed YSZ specimens have much greater bond strengths than do the thermally treated YSZ coatings. The implications of these results in terms of fracture mechanisms will be discussed later.

As indicated in Fig. 7, coatings which exhibit a high bond strength also exhibit a high AE count. It would, therefore, be interesting to attempt to relate high count-rate acoustic emissions with the various types of samples, their bond strengths, and fracture morphologies. The AE features of particular interest are the most frequent count rates and the period during a test in which high and low count rates occur (**i.e.** the progressive count-rate sequence). The AE data on final failure of the specimen are not included in this analysis.

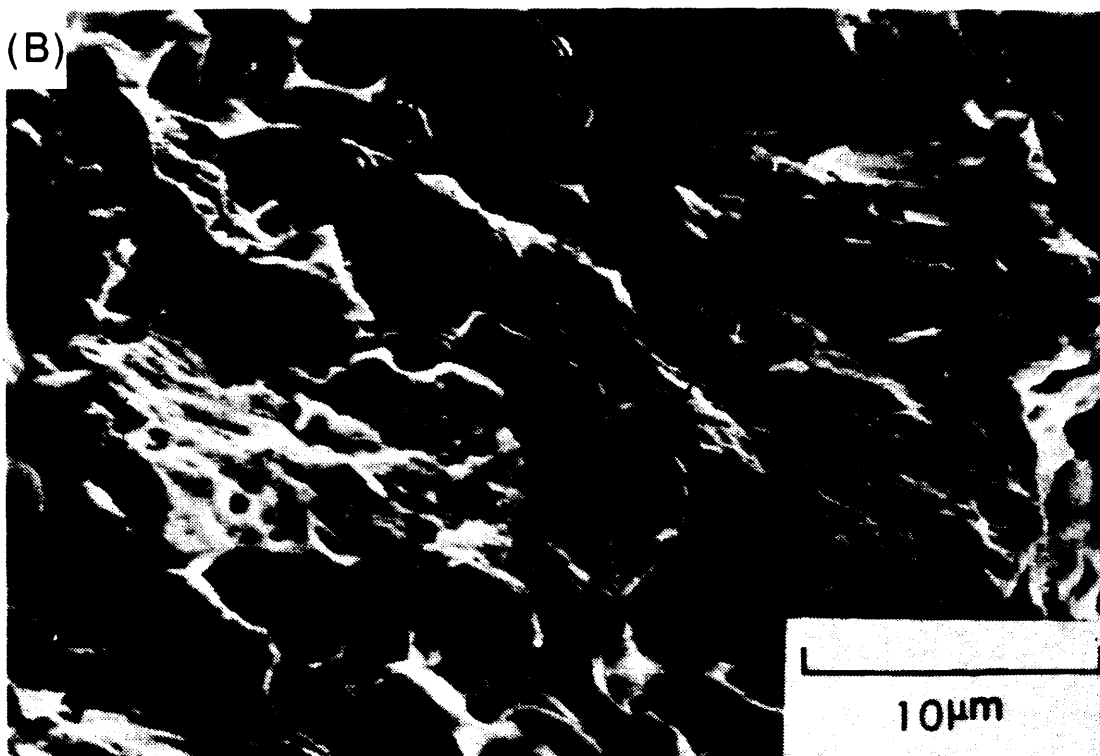
Fig. 8. Fracture surfaces of the failed YSZ coating: (A) adhesive-failure region showing interlamellar nature of the fracture; (B) cohesive-failure region showing both interlamellar (region "a") and translamellar fracture (region "b").

The adhesive-fracture region of the YSZ coating is shown in Fig. 8(A). Many cracks are apparent, and the fracture appears interlamellar, as noted by the distinct flat shapes of several of the particles. However, it should also be noted that the adhesive-failure morphology may have the characteristic of exhibiting very fine features since failure in this case would occur quite close to the substrate through the highly deformed and broken-up particles of the initially deposited material. These regions are more clearly distinguished at regions closer to the substrate part of the TAT specimen. Cohesive failure also exhibited flattened areas characteristic of interlamellar failure as shown in region "a" of Figure 8(B). There were also areas in which lamellar failure was observed in profile (i.e. the lamellae are viewed edge-on in area "a" of Fig. 8(B)): the resultant failure morphology is terraced or stepped. The fracture surface, therefore, shows more depth than the case of adhesive failures which are, in turn, relatively flat and planar.

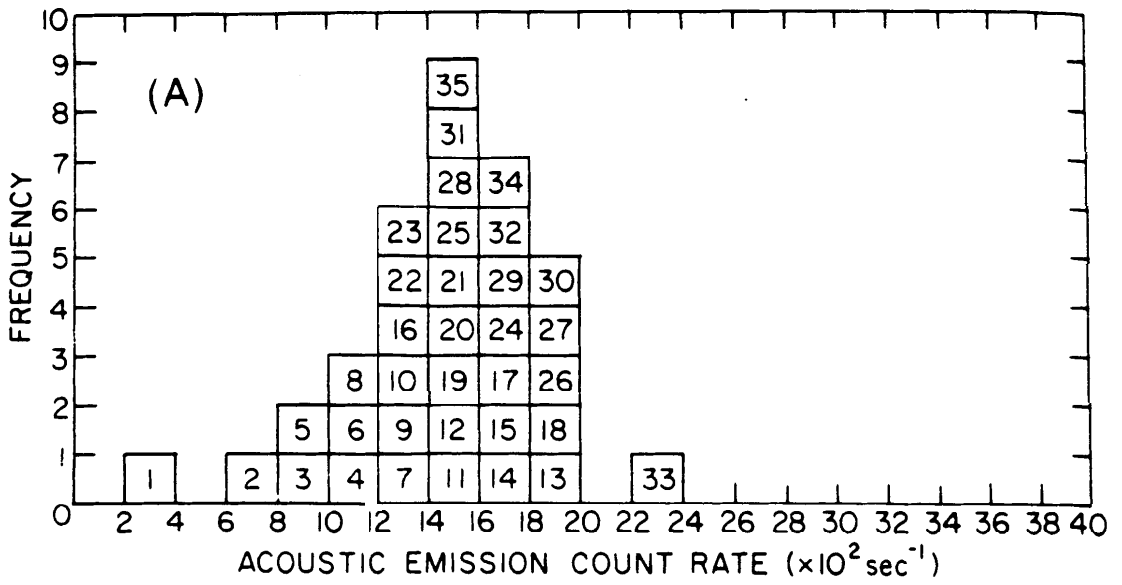
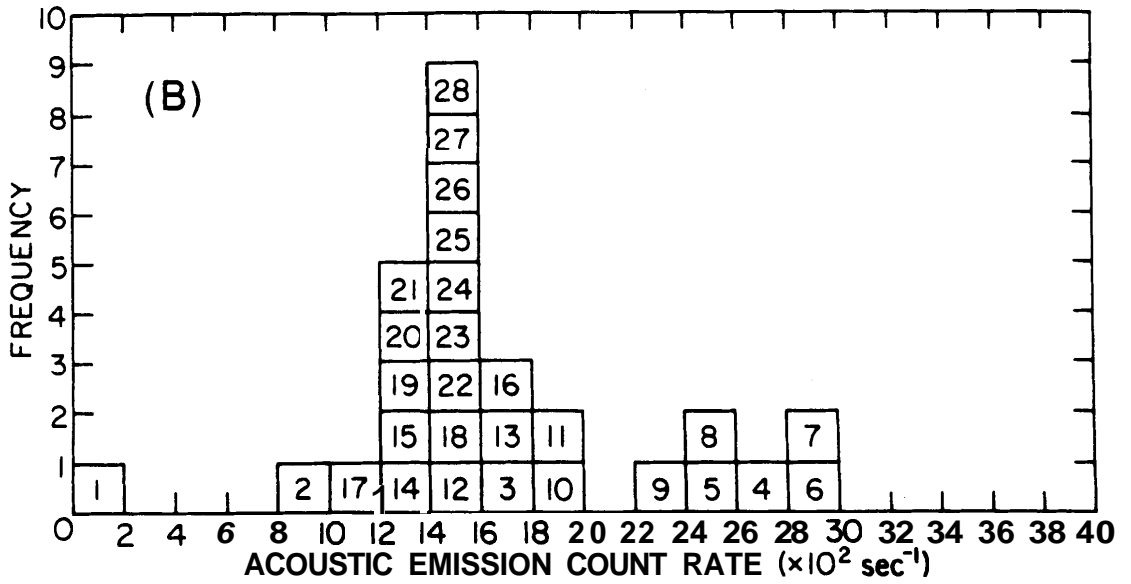
Fig. 9. The frequency of a specific count rate vs the count rate (where the numbers refer to the sequence in seconds) of a particular count rate: (A) the AE count rate increases with time, is maximum prior to failure, and corresponds to Fig. 5(A), i.e., skewed left; (B) the AE count rate increases to a maximum during the initial periods of the test and then decreases to a minimum prior to failure. This bimodal distribution corresponds to Fig. 5 (B), i.e., skewed right. (Counts at failure have not been included.)

- 1) Skewed left (Fig. **5(A)(ii)** and Fig. **9(A)**)—**the** count rate increases with time. Prior to failure, the count rate is maximum.
- 2) Skewed right (Fig. **5(B)(ii)** and Fig. **9(B)**)—**the** distribution is bimodal. Initially, the count rate is high, but after about one-third of the test time the count rate decreases significantly with a minimum occurring just prior to failure.
