Relationships between the mode II fracture toughness and microstructure of thermal spray coatings

P.J. Callus^{a,*}, C.C. Berndt^b

Abstract

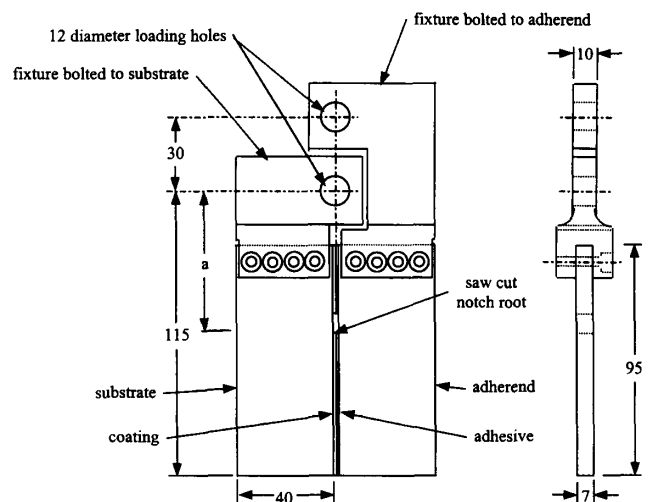
Fig. 1. Mode II test specimen and attached loading fixtures. All dimensions are in millimetres.

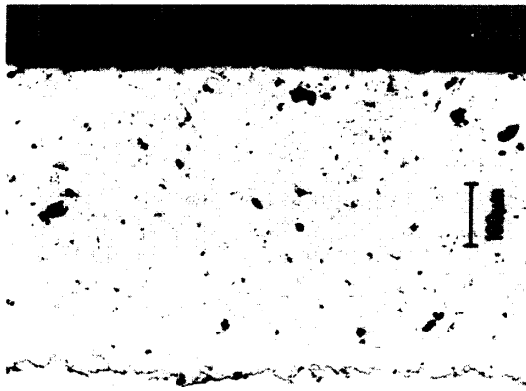
Batch 9, TiNi, Index 9

| Index | Batch | Material | Description |
|---|---|---|--|
| 9 | 9 | TiNi | High aspect ratio lamellae with no visible interlamellar interfaces or macroporosity. A number of larger unmelted particles |

Fig. 3. Cross-section of as-sprayed coatings indicating batch number, coating material and Cross-sectional Indices.

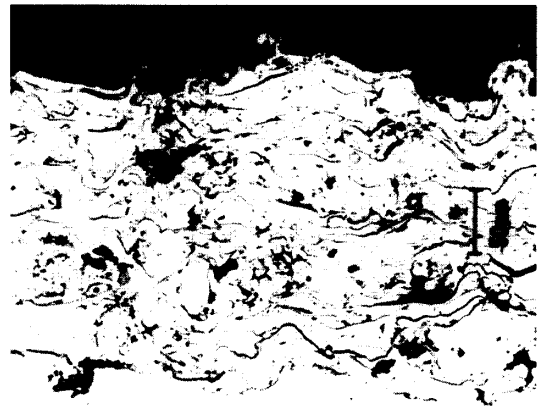
Batch 1, NiAl, Index 8

| Index | Batch | Material | Description |
|---|---|---|--|
| 8 | 1 | NiAl | High aspect ratio lamellae. Oxide film around lamellae is very thin and discontinuous. Few unmelted particles. Little porosity. Few oxide inclusions |

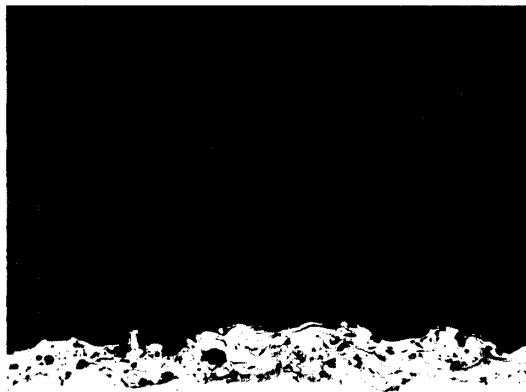
Batch 3, NiAl-Al₂O₃, Index 7

| Index | Batch | Material | Description |
|---|---|---|--|
| 7 | 3 | NiAl–Al ₂ O ₃ | Second highest macroporosity in terms of pore size and total pore volume. Pores distributed uniformly through the coating. No microcracking |

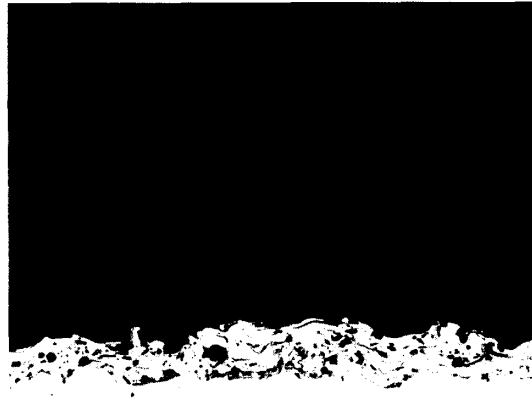
Batch 7, NiAl-YSZ, Index 2

| Index | Batch | Material | Description |
|---|---|---|--|
| 2 | 7 | NiAl–YSZ | Coatings contained distinct parallel microcracks 200 μm from the bond coat. Perpendicular microcracks were observed with a separation of 200–1000 μm |

In batches 7 and 8 severe cracks were observed parallel and perpendicular to the coating surface. As with batch 4 these cracks were caused by overheating of the coating, as a result of the raster distance and traverse speed being too low. In addition the melting of particles by the plasma plume during depositions were incomplete, resulting in the rough coating surface and lack of through-lamellae microcracks. To improve melting, the spray distance or powder feed rate should be decreased and/or the torch power increased.

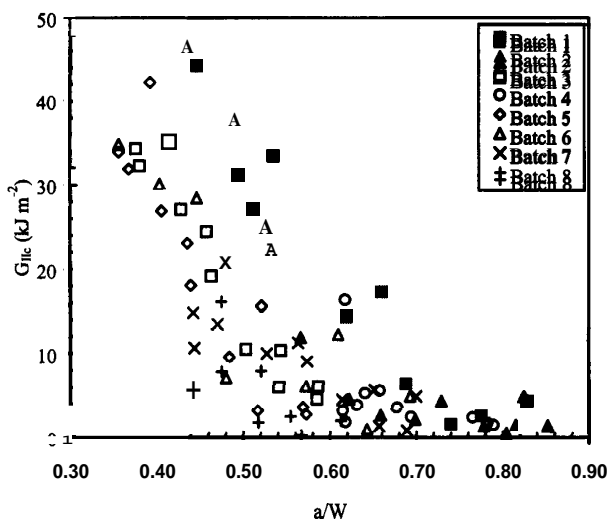
Fig. 5. Toughness of APS coatings for batches 1–8.

Unfortunately, all but two of the specimens from batches 1 and 2 failed at the epoxy–coating or epoxy–adherend interface. Clearly, the toughness of the coating

exceeded that of the adhesive and therefore the data shown in Fig. 5 for these batches must be regarded as a lower bound. In the two specimens where the fracture path was located entirely within the coating, cohesive failure, the fracture surfaces were reasonably rough and contained many shear hackles, a characteristic feature of mode II failure surfaces in polymer matrix composites [24].

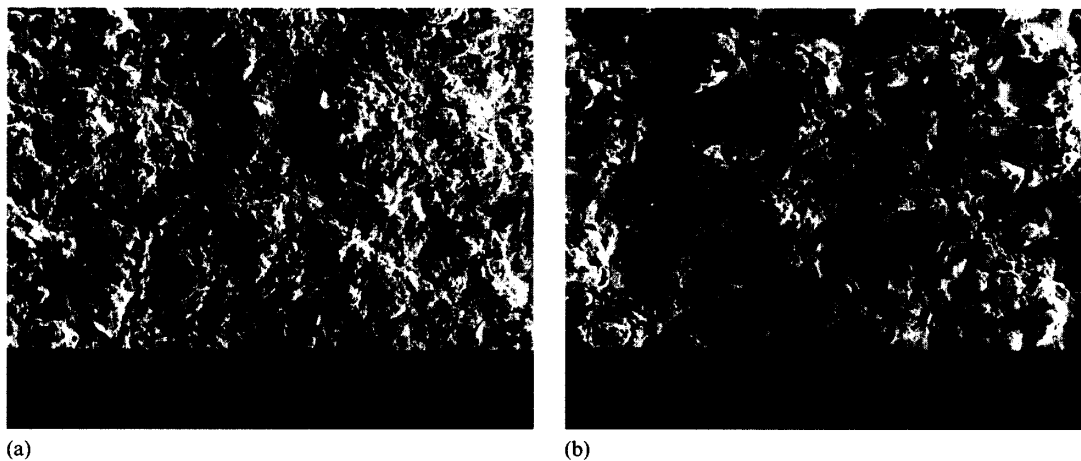
Fig. 8. (a) Representative cohesive failure surface for APS YSZ. (b) Representative failure surface at the bond coat–ceramic interface for four of the batch 7 specimens.

All specimens from batch 8 and eight specimens from batch 7 failed cohesively within the YSZ, a typical fracture surface being shown in Fig. 8(a). In the remaining four specimens from batch 7, the first 20–40 mm of failure were cohesive in the ceramic, followed by failure at the bond coat–ceramic interface. A representative fractograph of the interfacial fracture is shown in Fig. 8(b).

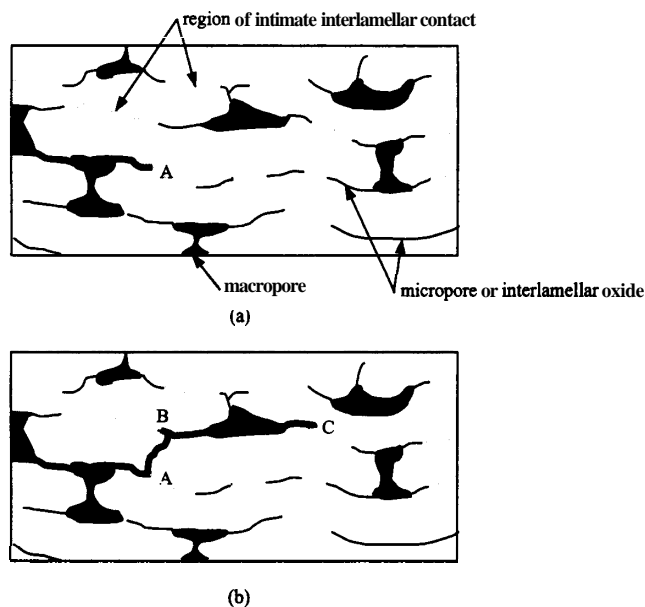
Fig. 9. Schematic representation of the crack propagation mechanisms within thermal spray coatings. (a) The original configuration, with the tip of a macro-crack at position A. (b) The propagation of a short trans-lamellar microcrack, from Position A to B, will result in an effective extension of the macro-crack to Position C.

Failure occurs when sufficient micropores have been connected by trans-lamellar microcracks to separate that region from the remainder of the coating.

Two of the unique microstructural features of thermal spray coatings facilitate this mechanism. Firstly, the majority of the fracture surface pre-exists in the as-sprayed coating as micropores. The only fresh crackling required is that to link these surfaces together. Secondly, this microporosity is oriented approximately in the plane of the coating. Therefore, most microcracks, which are simply micropores connected by trans-lamellar microcracks, also tend to be oriented in this plane. This results in spalling, which is particularly detrimental to

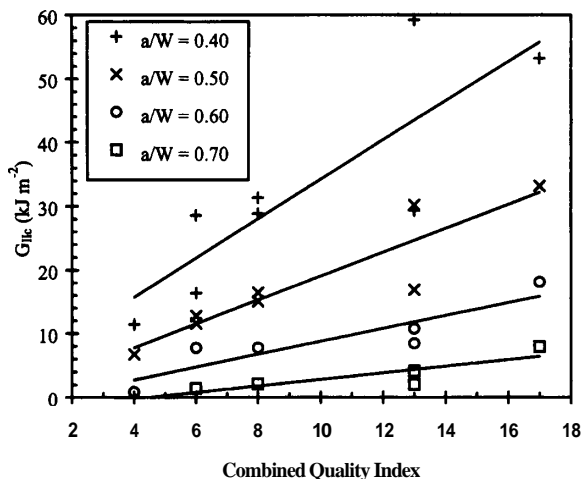
Fig. 10. Plot of fracture toughness versus the Combined Quality Index (sum of the Cross-sectional and Surface Quality Indices) for the indicated crack lengths.

Three features are evident in Fig. 10. Firstly, as discussed previously, toughness decreased as a/W increased. Secondly, for each crack length, the toughness

increased as the Combined Quality Index increased. This is significant since it verifies that the Indices were indeed identifying those features that controlled the fracture toughness of these coatings. The coatings with greater numbers of microcracks parallel to the substrate, unmelted particles and larger macroporosity exhibited a lower G_{IIC} . Finally, as a/W increased, the slope of the G_{IIC} versus Combined Index lines decreased. Further work will be required to determine whether this decreased discrimination between coatings at longer crack lengths was caused by a genuine coating response or specimen geometry effects.

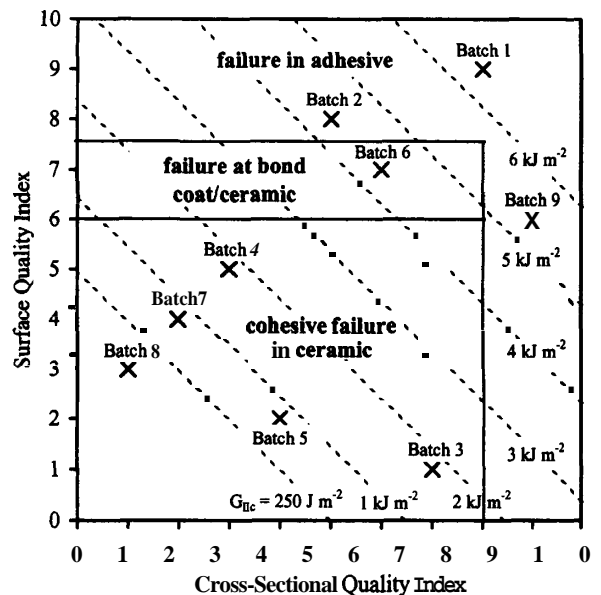
Fig. 11. Failure map for the thermal spray coatings tested in this work. The dashed diagonals are lines of constant G_{IIc} , the value of which is shown at the right-hand end of each diagonal. These data are derived from the $a/W=0.7$ line in Fig. 10.

The Quality Indices, fracture surface observations and G_{IIc} data were used to produce the failure map shown in Fig. 11. To construct this map, each batch was plotted according to its Cross-sectional and Surface Quality Indices. The failure morphologies of these batches were then used to generate the three characteristic failure zones. Finally, the G_{IIc} , determined using the data from Fig. 10 at $a/W=0.70$, were plotted onto the map as a family of diagonal lines (noting that the Combined Index was the sum of the Cross-sectional and Surface Quality Indices).

In general, the Surface Quality Indices matched the Cross-sectional Indices, and so the batches were clustered along the 45° diagonal of the map. This was expected, and supported the selection of the Combined Quality Index as the sum of the individual Quality Indices. The particular circumstances of the two batches

The toughness increased as the failure morphology changed from cohesive within the ceramic, to the bond coat/ceramic interface, to the adhesive. Most duplex coatings failed cohesively within the ceramic, although the highest quality of these coatings failed at the bond coat–ceramic interface. It appears that to maximize the performance of duplex coatings, it is necessary to ensure that the ceramic is sufficiently well bonded that it is the interface with other materials, such as the metallic bond coat, which becomes the weak link. Techniques have been developed to minimize property changes through coatings and thus increase the energy required to generate interfacial failure. These include the use of feedstock, which contains both ceramic and metallic powders, or grading the coating by increasing the proportion of ceramic in the feedstock as spraying proceeds.
